THE RE-SEALING OF JOINTS IN CAST IRON GUTTERS

Guidance Note November 2013

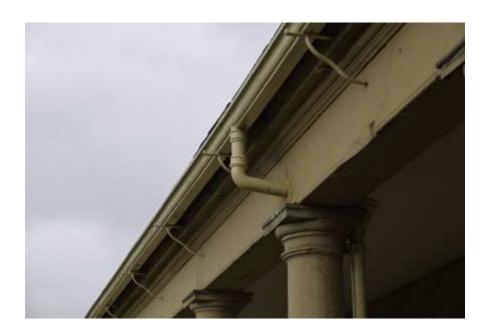
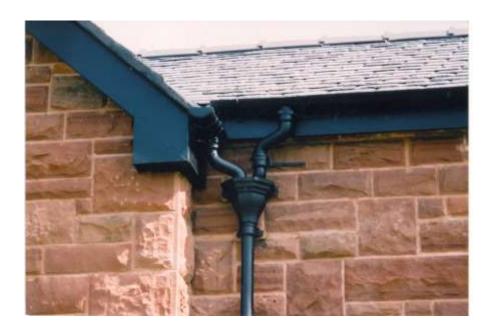
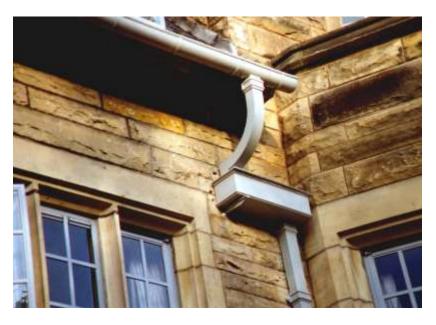
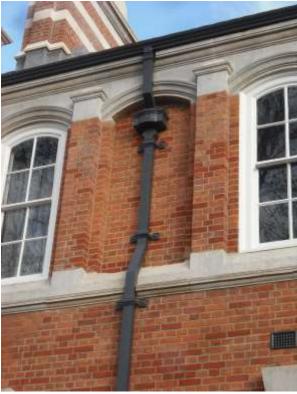
Typical examples of re-sealed joints

In summary, for leaking gutter joints it is <u>strongly</u> recommended to cut through the
jointing bolts, thoroughly cleaning the gutter and reseal with a modern low modulus
silicone sealant which will ensure many years of trouble free life.
